**Subject: Annual Inspection Report
Albertville Regional (Thomas J. Brumlik Field) Airport**

ANNUAL INSPECTION REPORT

July 20, 2011

ALBERTVILLE REGIONAL AIRPORT
(THOMAS J. BRUMLIK FIELD)
ALBERTVILLE, ALABAMA

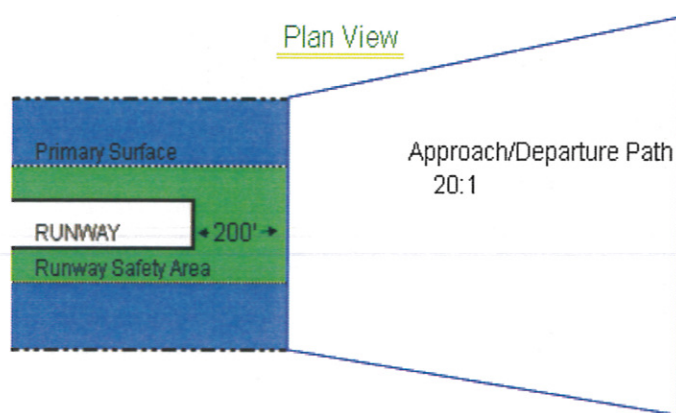
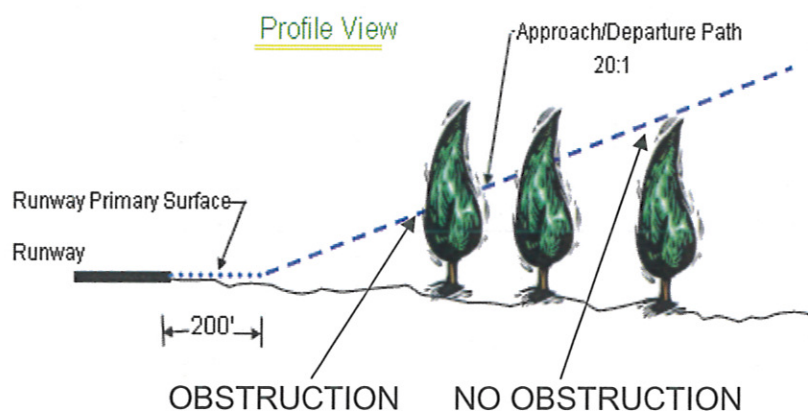
APPENDIX 1

Approach and Departure Path Dimensions			
Inner Width	Outer Width	Length	Acreage
250 Feet	450 Feet	1,000 Feet	8.04 Acres
Primary Surface Dimensions			
250 Feet Wide Centered Along Runway Centerline			
Extending 200 Feet Past the Runway End			
Runway Safety Area Dimensions			
120 Feet Wide Centered Along Runway Centerline			
Extending 200 Feet Past the Runway End
